Update "With-Site-Visit" Reserve Study

Parkside at Woodbridge Redmond, WA

Report #: 15035-3
For Period Beginning: January 1, 2014
Expires: December 31, 2014

Date Prepared: June 20, 2013

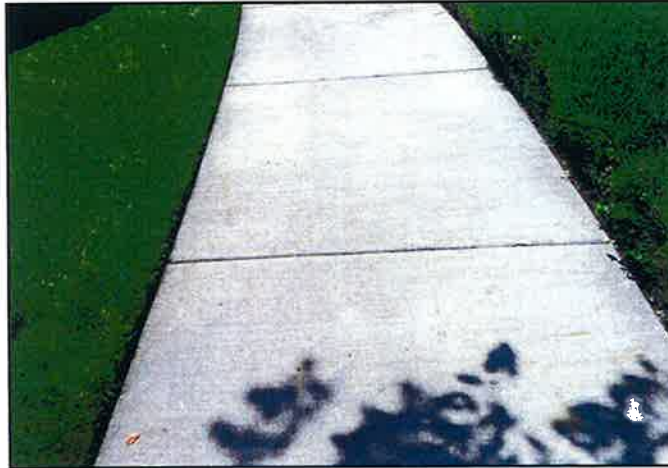
Comp #: 103 Concrete - Repair/Replace

Evaluation: Concrete flatwork is in overall good condition with no significant cracking or damage observed at this time. As routine maintenance, inspect regularly, pressure wash for appearance and repair/replace as needed using general operating funds. Continue to monitor as the Association ages and if regular patterns of deterioration emerge, funding may be incorporated into future reserve study updates. No basis for reserve funding at this time.

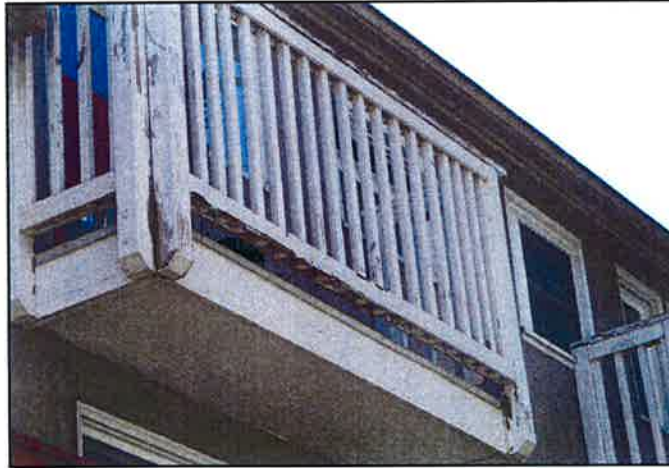
Comp #: 104 **Elastomeric Deck - Seal/Repair****Quantity:** Approx 580 GSF**Location:** Elevated decks adjacent to individual units

Evaluation: We did not closely inspect the decks due to access limitations. There are no reported problems at this time. This surface type needs to be top coated periodically for waterproof integrity, protection of surrounding wood structure and appearance. As routine maintenance, we recommend annual professional inspections, with cleaning and repair as needed. Clean with mild solution such as TSP; bleach can be added if mold/mildew become a problem.

\$6/GSF - Lower allowance to clean, prime and seal/top coat

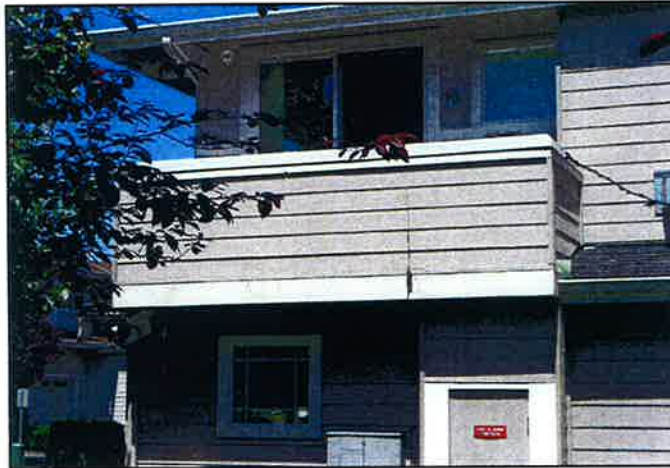
Comp #: 105 Elastomeric Deck - Repair/Replace

Evaluation: We cannot assume the decks have been correctly installed with proper flashings and adequate slope and drainage provision, as a reserve study conducts only a limited visual review for budget purposes. No reported problems at this time - periodic evaluations by architect or building envelope consultant are prudent. With proactive care and maintenance, there is no predictable expectation for large scale repair / replacement at this time.

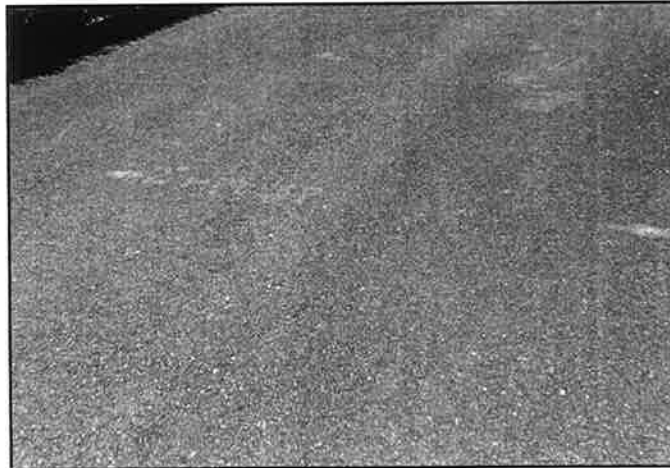
Evaluation: Asphalt is in overall good condition with some noted areas of damage. Recommend yearly inspections to ensure surface integrity and fill developing cracks. Also, shoulder design and maintenance are critical in maintaining the integrity of the asphalt. We recommend following WSDOT road design (cross section) recommendations, or engage an engineer to recommend specific design criteria for this community.

\$1.95/GSF - Lower allowance to mill and overlay

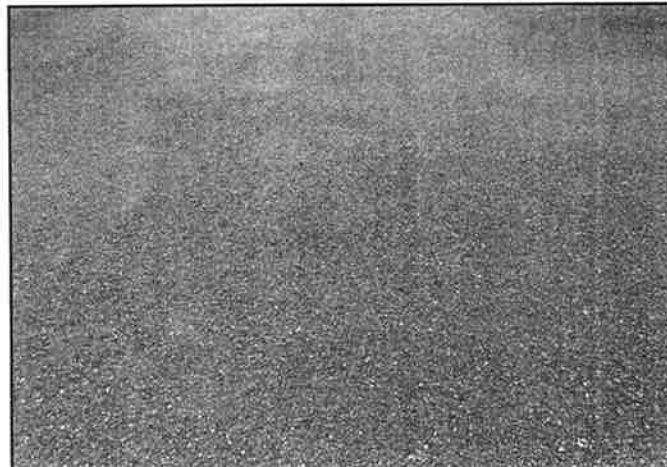
Comp #: 202 Asphalt - Seal/Repair

Evaluation: Asphalt surface is in fair condition with minor signs of drying. Seal coating does not add any structural integrity to the asphalt. However, seal coating protects the asphalt from UV deterioration and fills cracks typically no larger than 1/16". Recommend yearly inspections and crack/fill work to mitigate any subsurface moisture.

\$.20/GSF - Lower allowance to seal

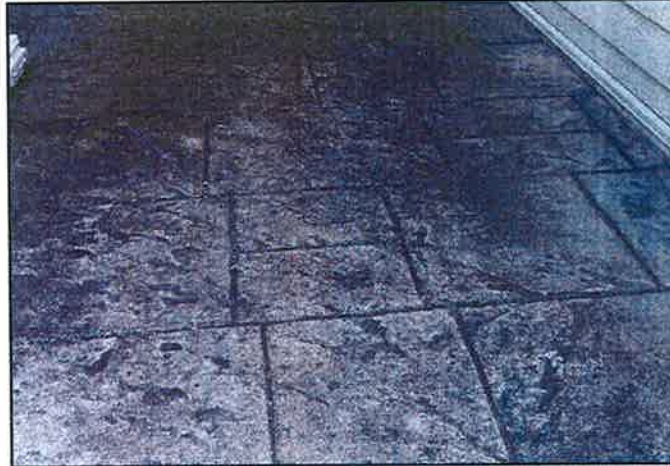
Comp #: 206 Special Concrete - Seal/Repair

Evaluation: Stamped concrete is in overall good to fair condition with no damage or significant cracking observed at this time. Inspect regularly, clean for appearance and repair as needed from operating budget. Some associations choose to apply sealer for enhanced appearance and water-shedding (~\$2 - \$3 / sq ft). No expectation of large scale expenses impacting reserves at this time, so no reserve funding suggested.

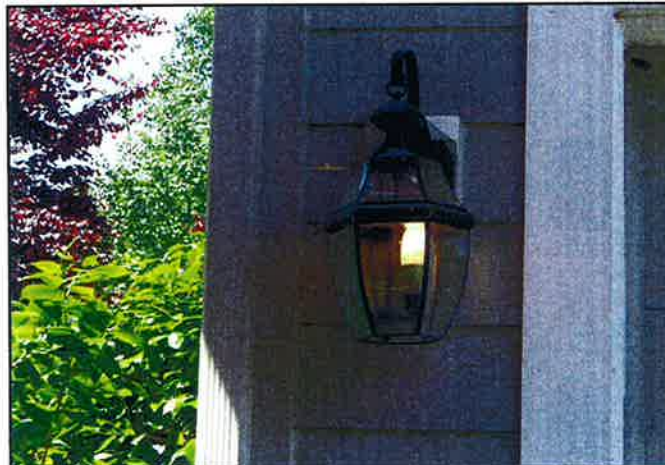
Comp #: 324 Exterior Lights - Replace

Evaluation: Exterior lighting is in overall fair condition with minimal fading depending on orientation and exposure. Lights were observed during daylight hours, but assumed to be in functional operating condition. As routine maintenance, clean by wiping down with an appropriate cleaner; change bulbs and repair as needed.

\$125/each - Lower average allowance to replace;
installed by electrician

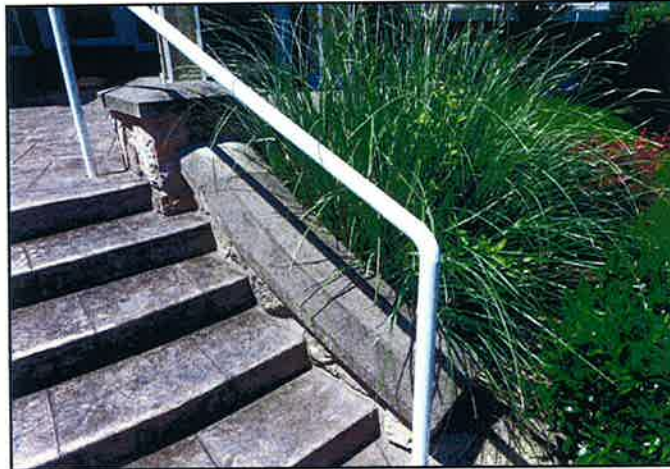
Comp #: 503 Metal Rail - Replace

Evaluation: Metal rails are in fair condition with no unusual deterioration observed at this time. Inspect regularly, clean for appearance, treat for corrosion and repair as needed from operating funds. Paint along with other exterior building paint projects. No reserve funding recommended at this time.

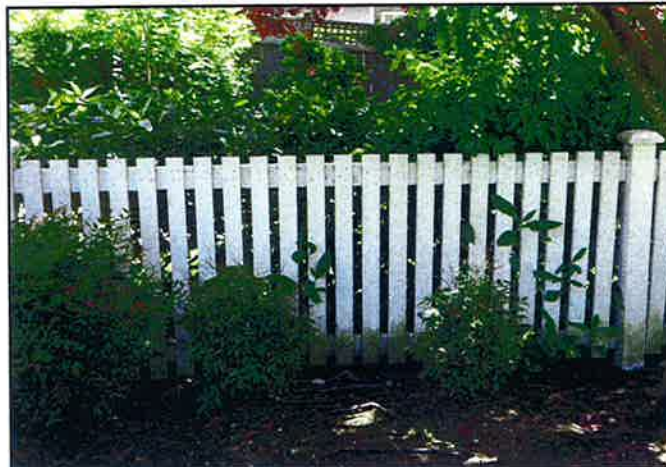
Comp #: 505 Wood Fence - Replace

Evaluation: 4' Wood fence is in good condition with no unusual deterioration observed at this time. As routine maintenance, inspect regularly for any damage, repair as needed. Avoid contact with ground and surrounding vegetation. Regular cycles of paint will help to maintain appearance and maximize life (see component #1109 Wood Fence - Seal/Paint).

\$20/LF - Lower allowance to replace

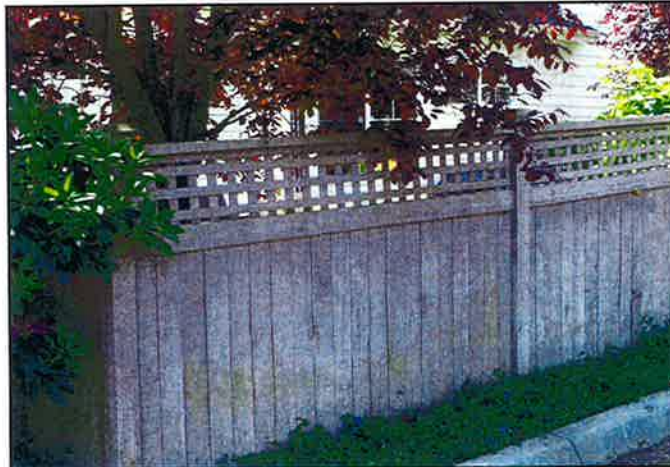
Comp #: 506 Privacy Fence - Replace

Evaluation: The 6 foot wood fence is in overall good condition with no widespread cracking, damage or loose sections evident at this time. Inspect regularly, touch up paint and complete minor repairs as needed from operating budget.

\$25/LF - Lower allowance to replace

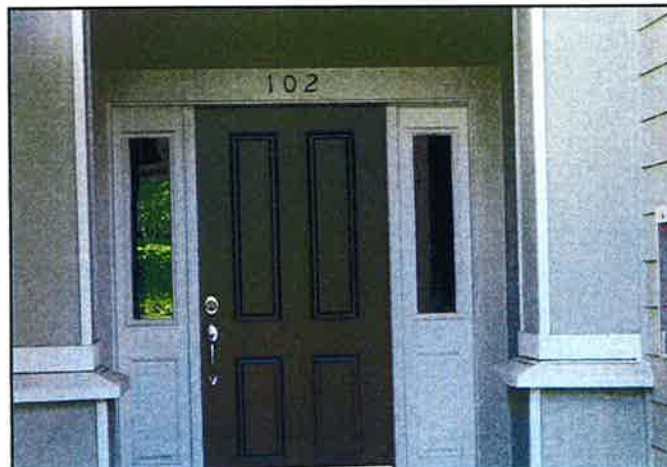
Comp #: 700 Entry Doors - Replace

Evaluation: The insulated metal doors are in good condition with no damage or deterioration observed. Inspect regularly, repair hardware as needed from maintenance budget. Clean and paint along with other exterior building surfaces, no need for separate funding. No expectation for large scale replacement at this time. No reserve funding recommended.

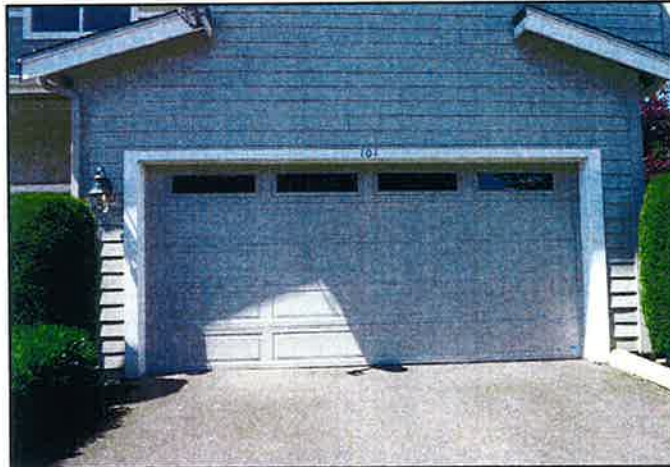
Comp #: 701 Garage Doors - Replace

Evaluation: The metal roll up garage doors are in overall good condition with no significant damage or unusual deterioration evident at this time. If not damaged or abused, expect extended life from these metal doors. Commercially applied finish is durable, but may need to be painted in future years. Anticipate replacement due to age and use.

\$500/each - Lower allowance to replace

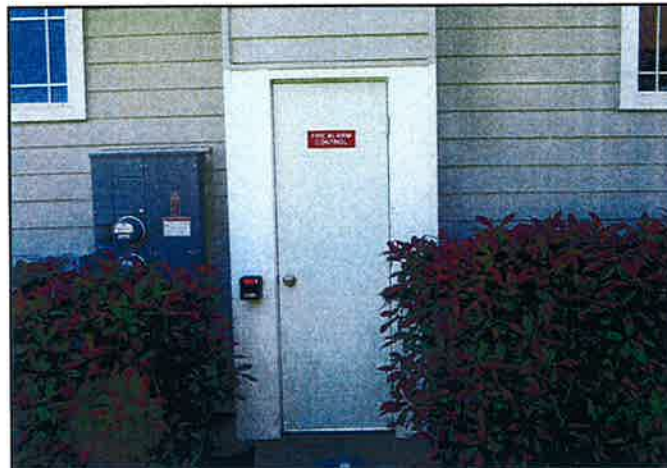
Comp #: 702 Utility Doors - Replace

Evaluation: Doors are in good condition with no significant cracking, damage or delaminating observed at this time. Repair hardware as needed as part of routine maintenance. Paint regularly as needed along with other building components. Replace doors as needed through the operating budget. No reserve funding suggested.

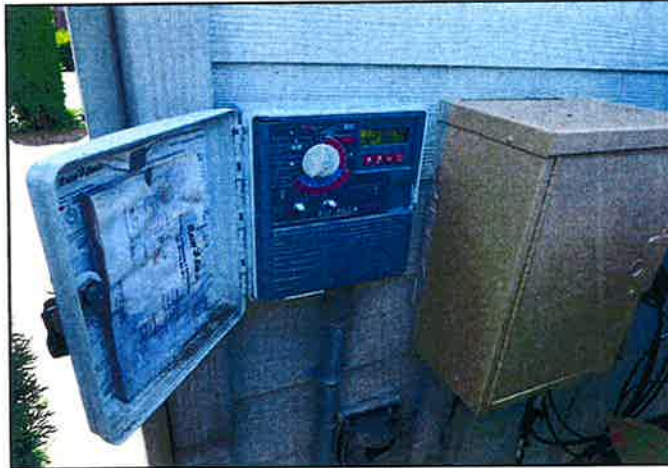
Comp #: 1002 Irrigation System - Repair/Replace

Evaluation: Irrigation system is assumed to be in functional operating condition. As routine maintenance, inspect and test system regularly, perform any minor repairs as necessary from operating budget. Follow proper winterization and spring start up procedures. Although the failure rate of the elements within this component are typically difficult to predict, as the system ages, periodic replacement of significant items such as clocks and back flow preventers can be expected.

Lower allowance to replace a portion

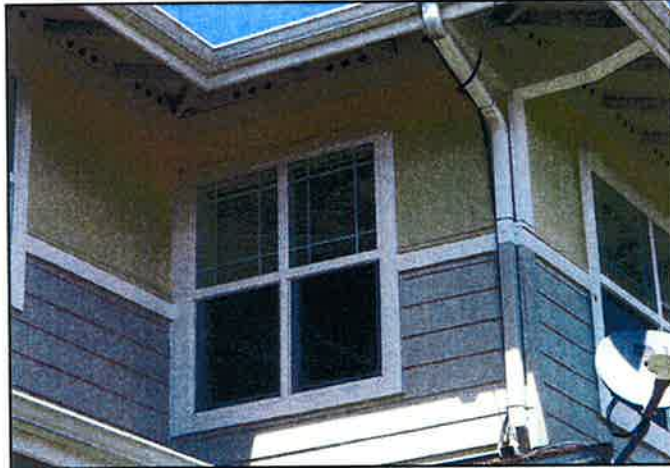
Comp #: 1100 Windows/Glass Doors -Replace

Evaluation: Windows appeared in fair condition during our limited scope visual inspection, with no deterioration or fogging apparent. We recommend regular professional inspections and prompt repair as needed to ensure building waterproofing and help prevent structural damage. If properly installed without defect, windows and glass doors are typically durable and have an extended useful life; however, we recommend to plan for eventual replacement at the time frame indicated below. Note: there are many types of glazing and windows available in today's market, a general mid-range funding allowance is factored below. Timed below logically with siding.

\$800/each - Lower average allowance to replace

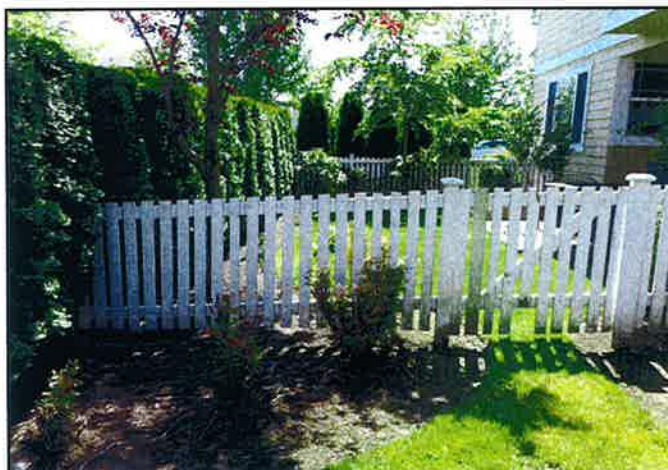
Evaluation: We recommend the regular application of a quality exterior paint, on both sides of the wood fencing for appearance, protection of wood and maximum design life. Remove any contact with ground and surrounding landscape, repair as needed and clean prior to sealer application. Pay particular attention to end grains of fence to help prevent water from wicking into wood.

\$.75/GSF - Lower allowance to clean and seal both sides of wood fencing

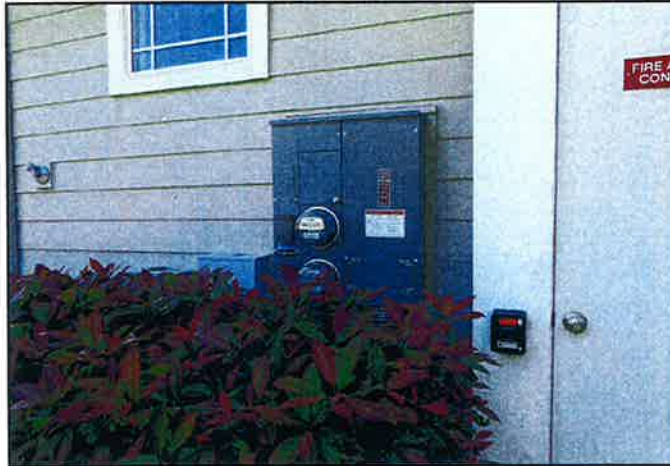
Comp #: 1812 Electrical - Repair/Replace**Quantity:** Extensive Systems**Location:** Throughout common and limited common areas

Evaluation: No reported problems at this time. Assessing the electrical systems is beyond the scope of our services. If installed per architectural specifications and local building codes, there is no predictable time frame for large scale repair/replacement expenses within the scope of our report. Treat minor repairs as ongoing maintenance expense. Funding may be incorporated into future reserve study updates if conditions change. No reserve funding suggested at this time.
